ALLGEYER LAKE DAM

MONTGOMERY COUNTY, MISSOURI

MO. 30376

**PHASE 1 INSPECTION REPORT
NATIONAL DAM SAFETY PROGRAM**

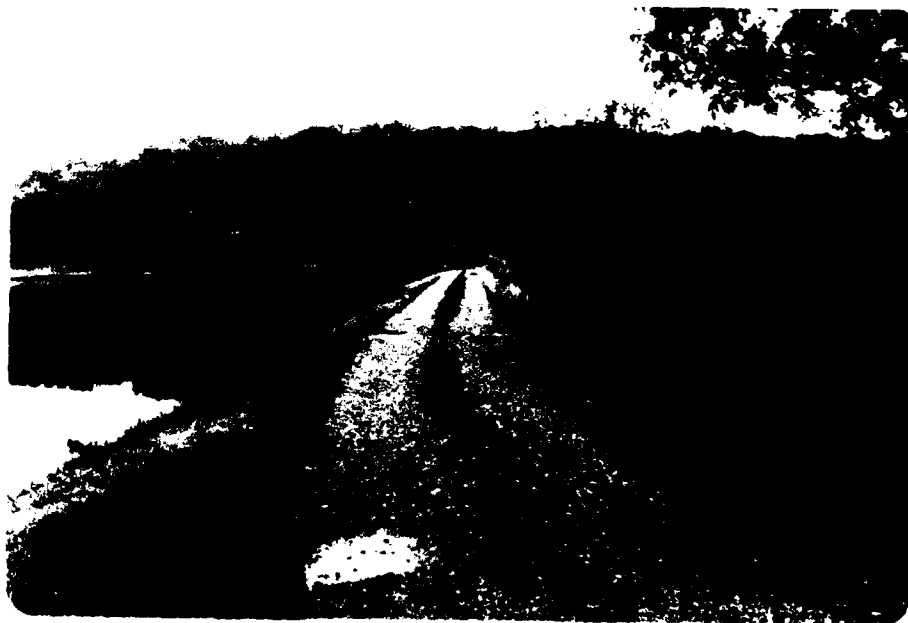
- (3) Crest. The crest is covered with cherty gravel and serves as a roadway. A few potholes and ponding water were observed on the crest. Measurements along

the centerline indicate that the center section is about 1.5 feet higher than the ends, probably due to overfill to compensate for settlement which hasn't occurred. No cracks or deformations were observed. The maximum crest elevation of 761.5 feet (measured) is slightly higher than the revised plan elevation of 107.5 (unsettled top) which is equivalent to elevation 760.8 feet.

PHOTO NO. 3 - CREST TAKEN FROM RIGHT SIDE

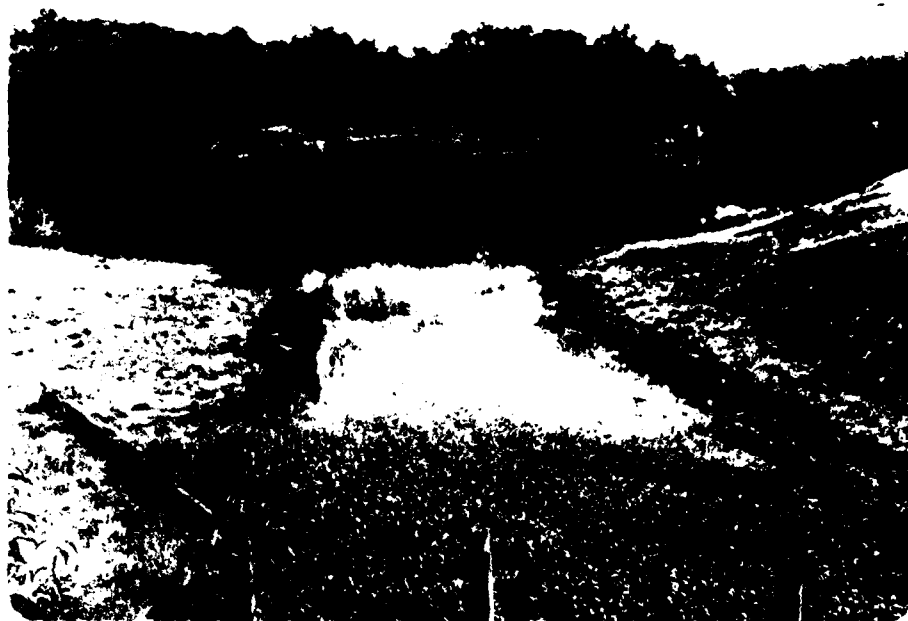
(2) The emergency spillway consists of a vegetated earth channel controlled by an 18 inch diameter CMP culvert through the roadway that crosses the spillway. The roadway and culvert were installed in the spillway a couple of years after the dam was constructed. No erosion was noted in the spillway or exit section. The trash line upstream from the culvert indicated that the reservoir level had been up to or slightly above the invert elevation of the pipe. Discharge from the spillway should not impair the integrity of the dam.

PHOTO NO. 6 - VIEW UPSTREAM IN EMERGENCY SPILLWAY

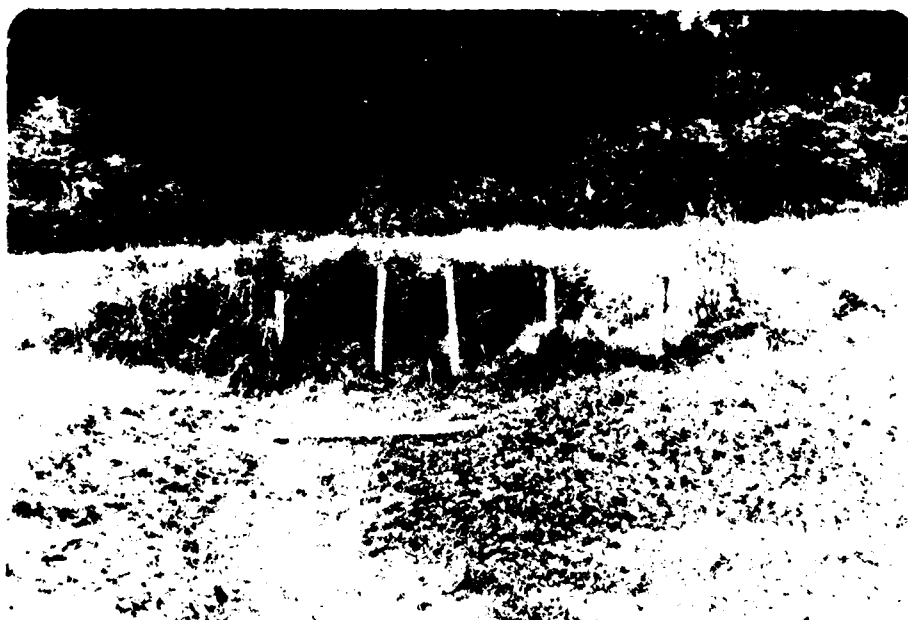
PHOTO NO. 7 - VIEW DOWNSTREAM IN EMERGENCY SPILLWAY SHOWING
ROAD SPANNING SPILLWAY

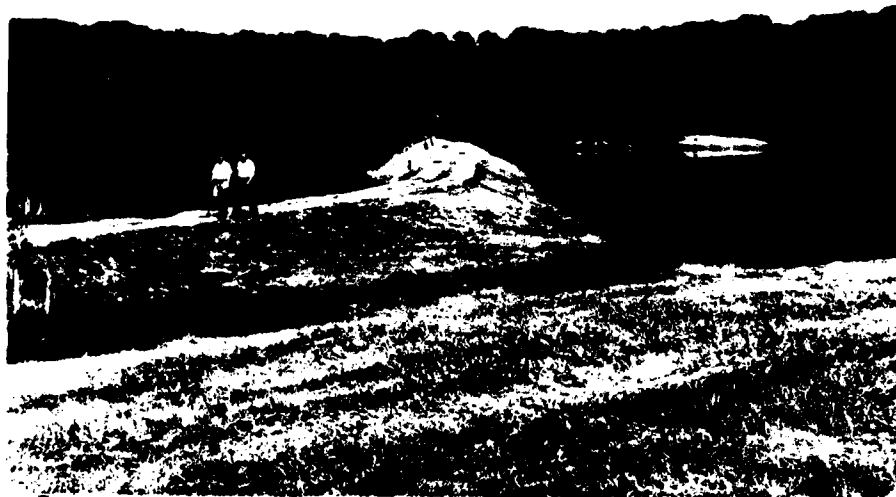
PHOTO NO. 8 - CREST LOOKING ACROSS EMERGENCY SPILLWAY

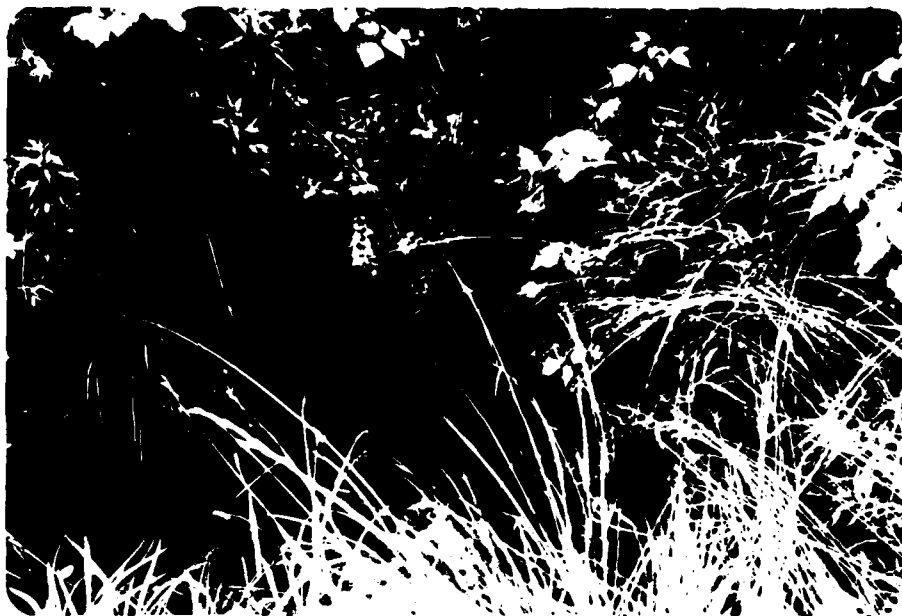
PHOTO NO. 10 - DOWNSTREAM END OF PRINCIPAL SPILLWAY
